TECHNICAL BULLETIN

Preventing Storage Corrosion or Staining on Pre-painted and Galvanized Building Panels and Components

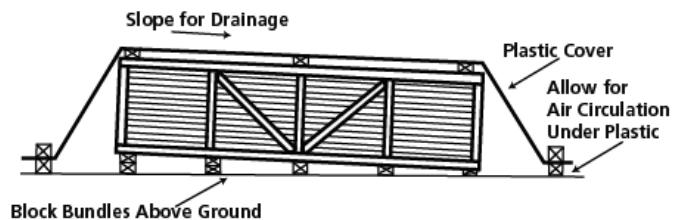
Prolonged storage will always increase the likelihood of storage corrosion; therefore, the best prevention is to minimize the storage time. Proper storage limits the collection of water from rain, snow and condensation on the panel surfaces. Under roof storage is always preferred. If panel bundles or other components have to be stored outdoors, a number of precautions must be taken to prevent storage corrosion. Material should be stored in a level area out of the way of other activities to minimize the number of movements required. If the material is stored on the ground, i.e. dirt, grass or gravel, a plastic ground cover must be put down to minimize condensation of water from the ground onto the panels or components. The material must then be raised off the plastic ground cover to avoid contact with water puddles, and allow for air circulation to promote drying of condensed water. **The material must be stored on an angle, or slope, to promote drainage of water.**

Wet, uncured or pretreated lumber should not come in contact with the material. Sufficient support must be provided to the raised and angled material to avoid excessive bowing, which may result in low spots that could hold water.
