INTRODUCTION

STORAGE

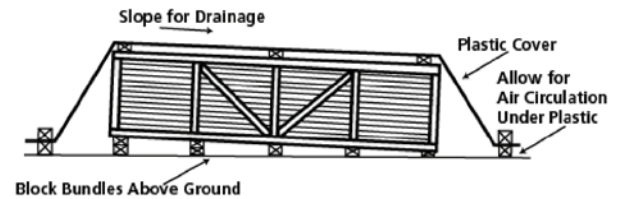
required. If the material is stored on the ground, i.e. dirt, grass or gravel, a plastic ground cover must be put down to minimize condensation of water from the ground onto the panels or components. The material must then be raised off the plastic ground cover to avoid contact with water puddles, and allow for air circulation to promote drying of condensed water. The material must be stored on an angle, or slope, to promote drainage of water.

Wet, uncured or pretreated lumber should not come in contact with the material. Sufficient support must be provided to the raised and angled material to avoid excessive bowing, which may result in low spots that could hold water.
